FIELD HERNIOPLASTY USING PVC INSECT SCREEN MESH FOR TRAUMATIC VENTRAL ABDOMINAL HERNIA IN A JERSEY CROSSBRED COW IN BHUTAN: A CASE REPORT

¹District Veterinary Hospital, Mongar Dzongkhag Administration, Bhutan

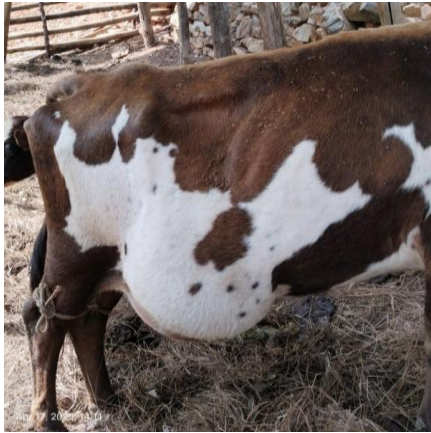
The animal was bright, active, and responsive on clinical examination of the vital parameters. On physical examination, a soft, fluctuant, voluminous swelling was observed on the right lateral ventral side of the abdomen (Figure 1). Palpation revealed a distinct hernial ring at the dorsal margin. Manual pressure applied to the swelling demonstrated that the hernial contents were readily reducible, confirming the absence of adhesion formation and vascular compromise. The overlying skin was intact, with no evidence of ulceration, excoriation, or secondary infection. Auscultation of the hernial sac revealed bowel sounds consistent

Figure 1: Voluminous reducible right lateral ventral abdominal hernia in the Jersey crossbred cow.

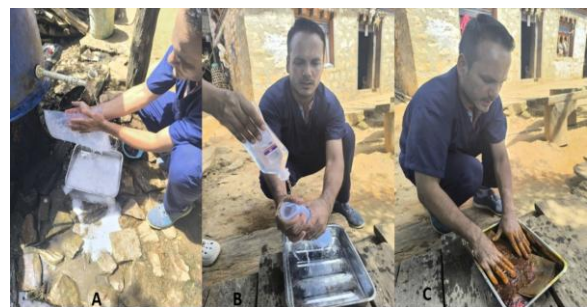
Figure 2: (A) Washing of PVC insect screen mesh using detergent and water; (B) rinsing with normal saline; (C) soaking in a povidone-iodine solution

A Polyvinyl Chloride (PVC) insect screen mesh was aseptically prepared in the field before implantation. The mesh was cut after measuring the circumference of the hernial mass and thoroughly washed with a detergent solution to remove manufacturing residues, particulate matter, or surface contaminants.

The mesh was further rinsed copiously with sterile normal saline (0.9% NaCl) to remove residual detergents, then soaked in 10% povidone-iodine solution for approximately 15–20 minutes before use (Figure 2). This mechanical cleaning followed by chemical antiseptics represents a field-applicable decontamination approach in resource-limited veterinary surgical settings, in consonance with findings of Mosbah and Abouelnasr (2015) and Chandran et al. (2024). Povidone-iodine was used as the chemical disinfectant for the instruments used during the surgical correction of the hernia.

The mesh was decontaminated using a series of methods, including detergent washing, normal saline rinsing, and soaking in a 10% povidone-iodine solution, in the absence of proper autoclaving facilities in the field. This preparation is consistent with field-adapted disinfection practices documented for prosthetic implants in resource-limited veterinary settings (Mosbah and Abouelnasr 2015). Povidone-iodine is a well-established broad-spectrum antimicrobial agent with proven efficacy against bacteria, fungi, viruses, and spores, and its use as a disinfecting agent for surgical equipment in the field is well demonstrated (Bilsel and Abci 2012). Detergent washing facilitates removal of the organic matter and debris, which is important because organic matter can reduce the effectiveness of chemical antiseptics (Chandran et al. 2024).

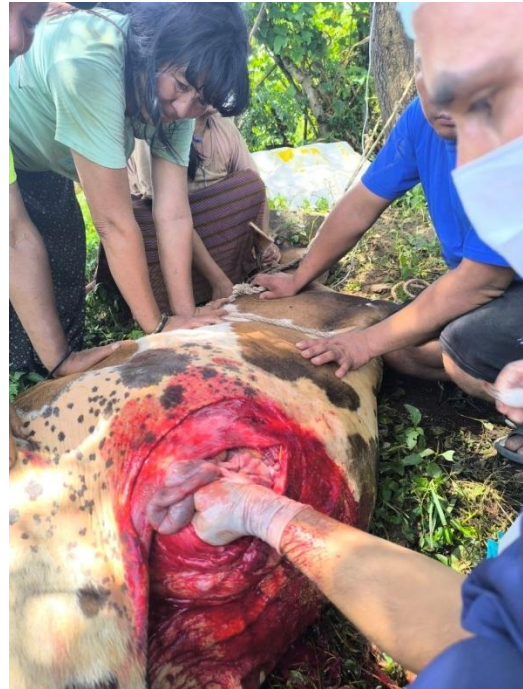
Figure 3: Intraoperative exposure of the hernial sac showing reducible intestinal loops prior to mesh placement.

A linear skin incision was made through the hernial sac, parallel to and slightly below the hernial ring to facilitate the repair. The skin and subcutaneous tissue were carefully dissected using atraumatic dissection to reveal the hernial sac and outline the margins of the hernial ring (Figure 3). The hernial sac was opened, and its contents, comprising loops of the small and large intestines, were examined. No evidence of vascular compromise, strangulation, or necrosis was found, and the contents were manually retracted into the abdominal cavity. Fibrous tissues along the hernial ring were excised to freshen the wound margins for subsequent adhesion. The prepared PVC insect screen mesh was cut to extend at least 2 cm beyond the circumferential margins of the hernial defect. The mesh was placed as an onlay repair over the hernial ring and sutured to the surrounding muscular and fascial tissues using a simple interrupted suture pattern. Non-absorbable suture material nylon (polyamide) monofilament suture, USP size 1 (IRELYON PAC, M 905 LS) was placed at intervals of approximately 1.5–2 cm (Figure 4). The subcutaneous layer was closed using an absorbable suture in a simple continuous pattern, and the skin was apposed using a non-absorbable monofilament suture in a horizontal mattress pattern. The surgical site was thoroughly scrubbed and dressed with topical gamma benzene hexachloride (GBH) cream.

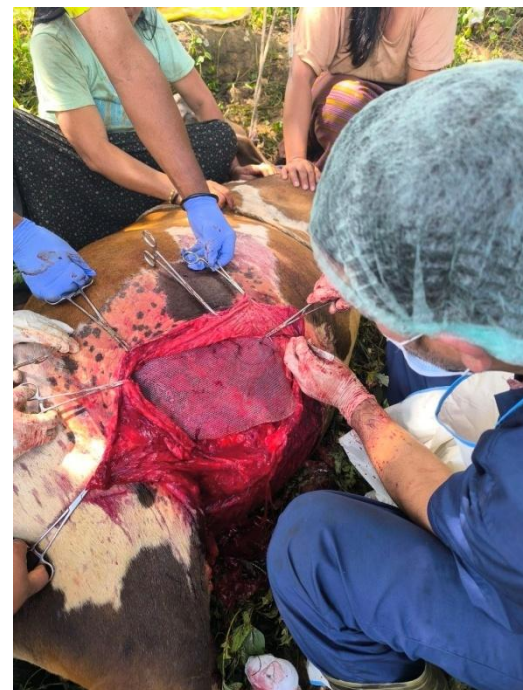
Figure 4: PVC insect screen mesh secured over the hernial defect with simple interrupted sutures.

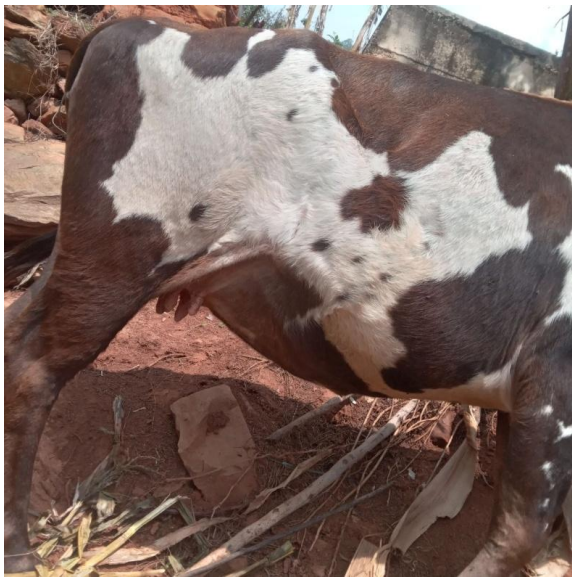
Figure 5: Complete wound healing at day 90 post-operation.

time wound healing was achieved. At the 90-day follow-up, the abdominal contour had returned to its original condition with no signs of hernia recurrence, and the animal was healthy (Figure 5). Additionally, the animal was confirmed to be pregnant at the 90-day follow-up, demonstrating complete restoration of reproductive and productive function, an important outcome for smallholder dairy farming in Bhutan.
